# VALLEY ELEMENTARY SCHOOL FEASIBILITY STUDY

Prepared for Frederick County Public Schools

By: Proffitt & Associates Architects

March 24, 2021

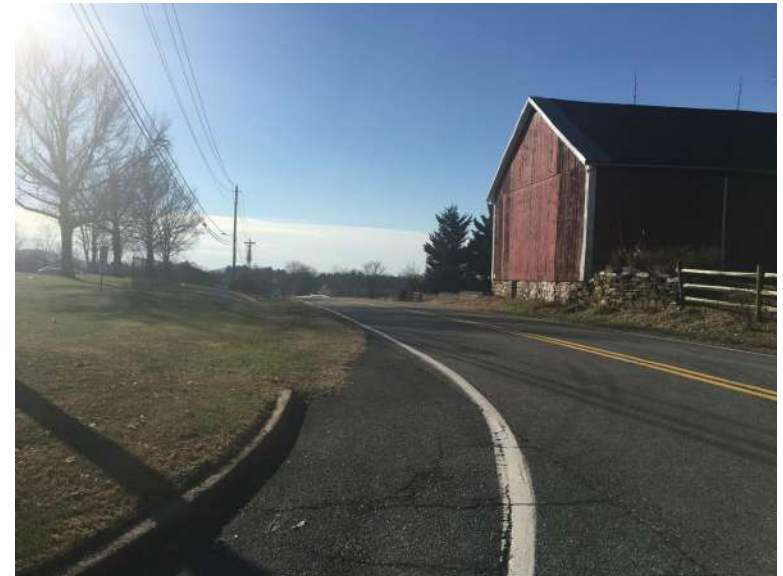
View to south along Horine Road with slight crown

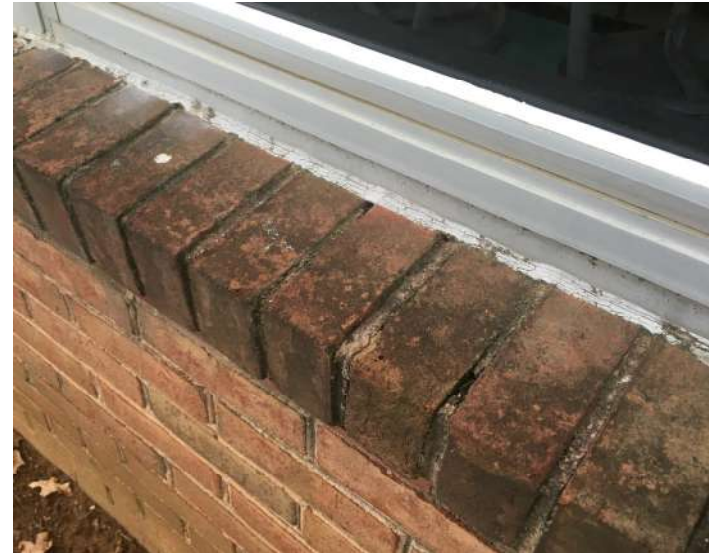
The masonry is in fair to poor condition, with many areas which require repair and/or repointing. Large sections of horizontal mortar joints are missing around the entire perimeter of the original building. It is evident that the problem has been ongoing because there are areas that have clearly been previously repaired. The brick rowlock sills also require repointing. Some of them have significant algae growth, which may indicate that they are not shedding water efficiently after a rain event. The areas of the original building with the marble chips over CMU are exhibiting cracking throughout and have obviously been patched over the years.

Rowlock sills in need of repointing

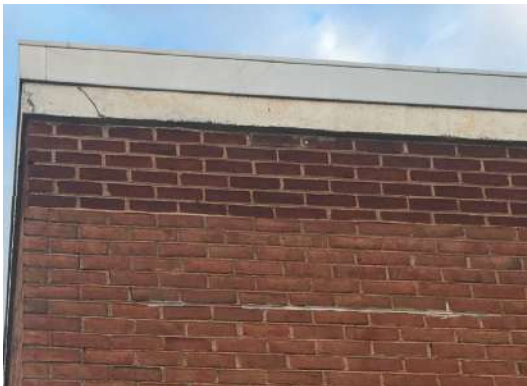
Mortar joint repairs, cracking marble course

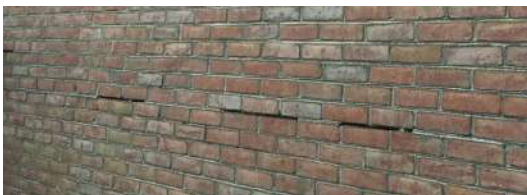
Areas of horizontal mortar joints missing

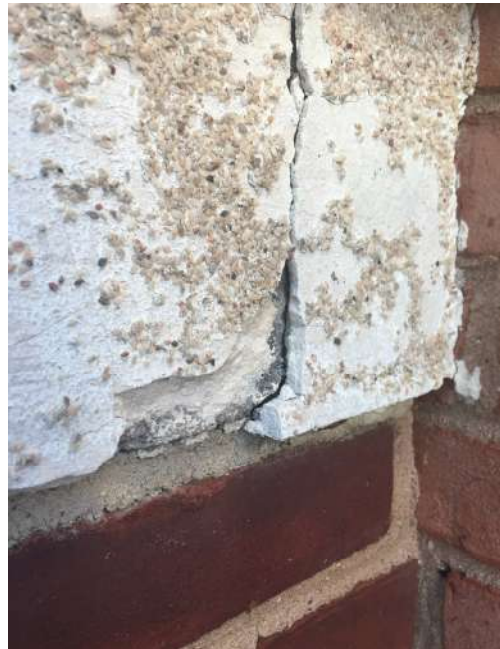
Detail of marble chip course cracking

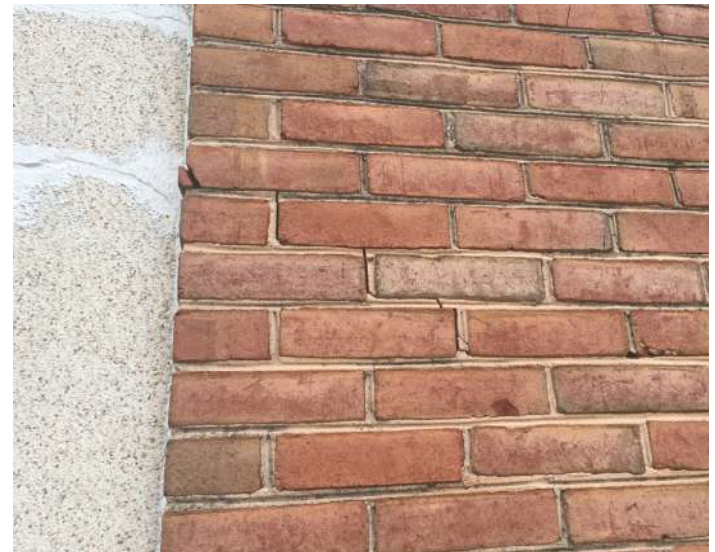
Brick corner chipped and stairstep cracking

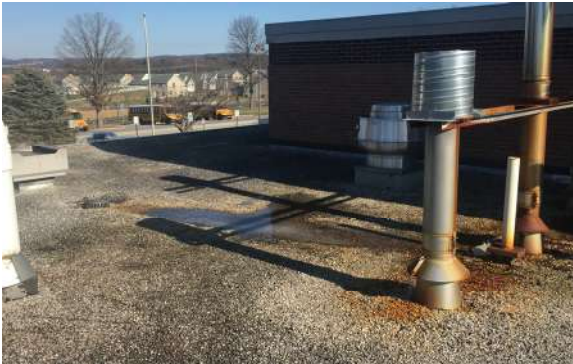
Area of standing water at mechanical room roof

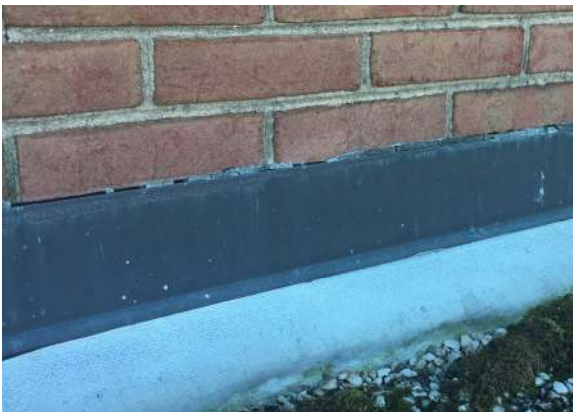
Deteriorating sealant at flashing reglet

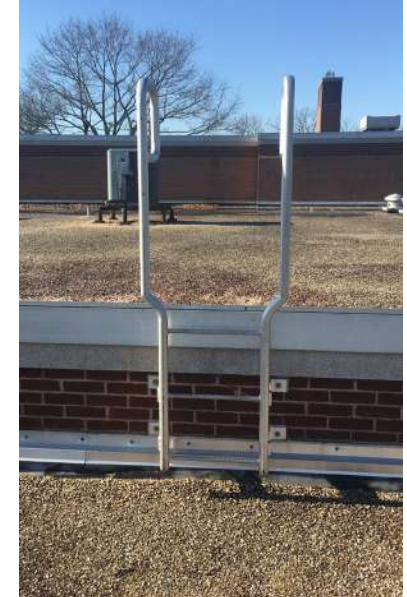
Transition ladders are provided for travel between the various roof elevations and generally appear to be code compliant in terms of dimensions and clearances. One of the shorter transition ladders appears to be anchored to the structure at only one location vertically and set down on wood blocking but does not appear to be permanently affixed thereto. We would recommend that the attachment methods be reviewed and modified to meet codes and provide stable transition.

Roof transition ladder

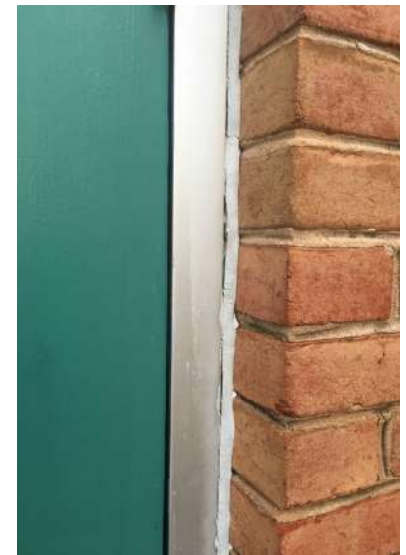
Failing sealant at frame

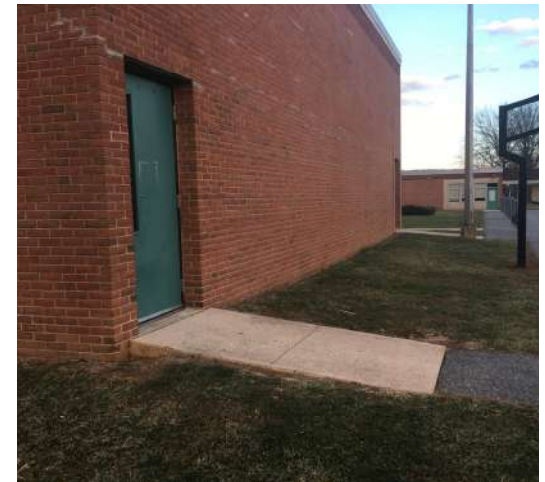
Many exterior egress doors do not have level landings at the exterior

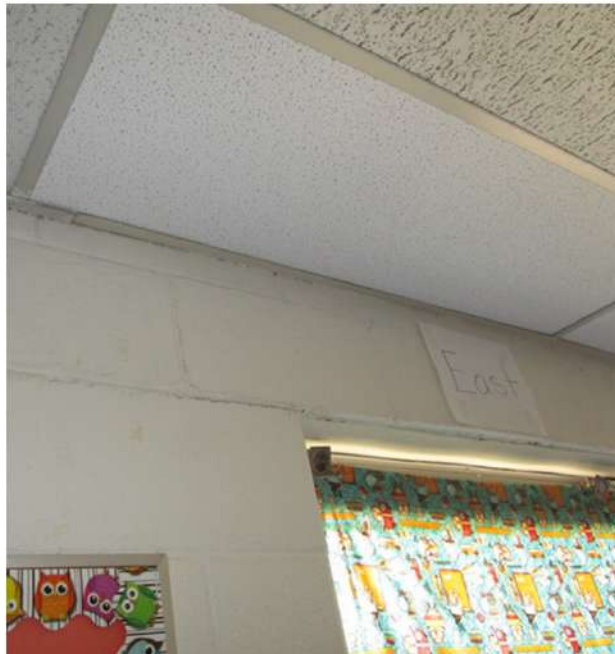
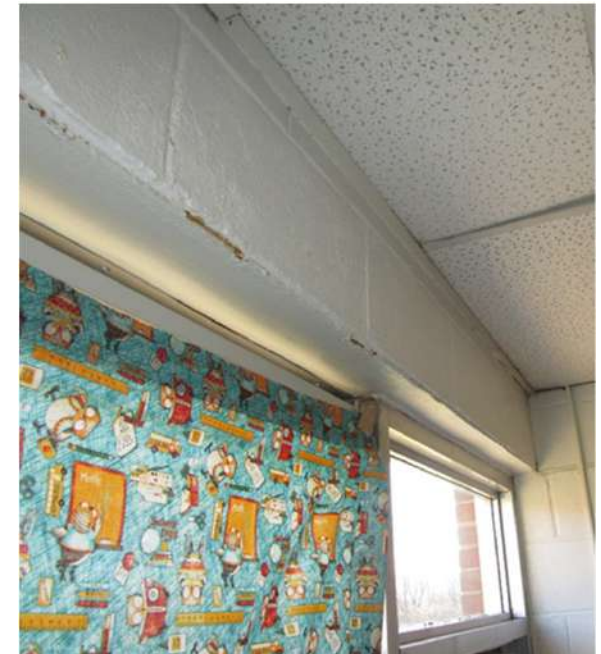
1. The exterior walls in the first classroom wing are cracked at approximately 7 exterior lintels. [See Photos 1A, 1B]

Photos 1A and 1B: First classroom Wing – Steel Lintel and CMU jamb damage

- 1.1 Recommendation: Expose the steel lintels and beams and remove all rust, repaint, or replace; Rebuilding the masonry jambs at these locations from slab on grade level to lintel elevation.

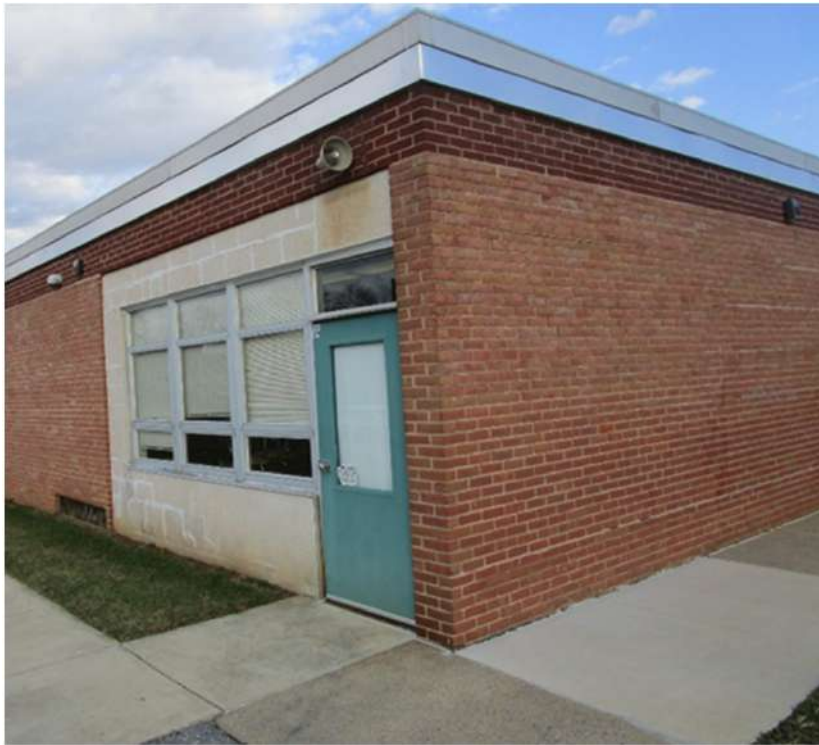
2. The southwest corner of the first classroom wing is experiencing some distress, stair-step cracks, pavement settlement, lintel cracks, possibly all due to settlement. [Photo 2]
  - 2.1 Recommendation: Demolishing the wall in this corner to the foundation level, verifying the soil bearing does not need remediation, and then rebuilding the wall.
3. The exterior wall lintels at the southeast and northeast corners of the first classroom wing appear to be significantly rusted. These lintels consist of W8 beams with a steel plate welded directly to the bottom flange. [Photo 3]
  - 3.1 Recommendation: Remove these W8 lintels and rebuild a CMU lintel over the windows at these two (2) locations.

Photo 2: First Classroom Wing SW corner – possible foundation settlement

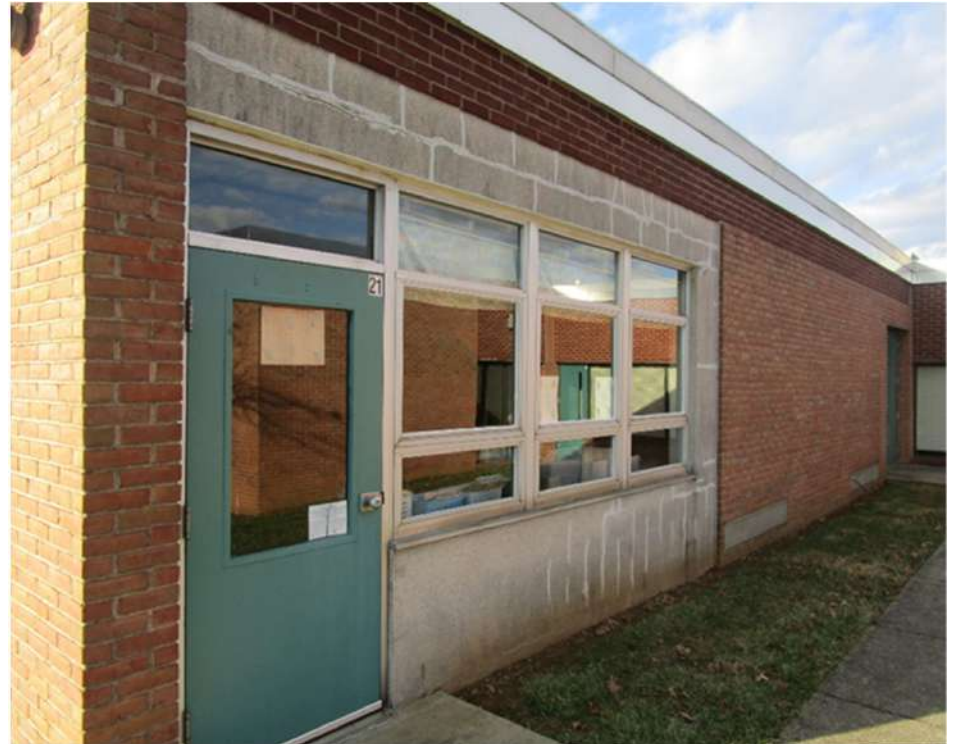
Photo 3: First Classroom Wing East corner lintels – replace lintel beam

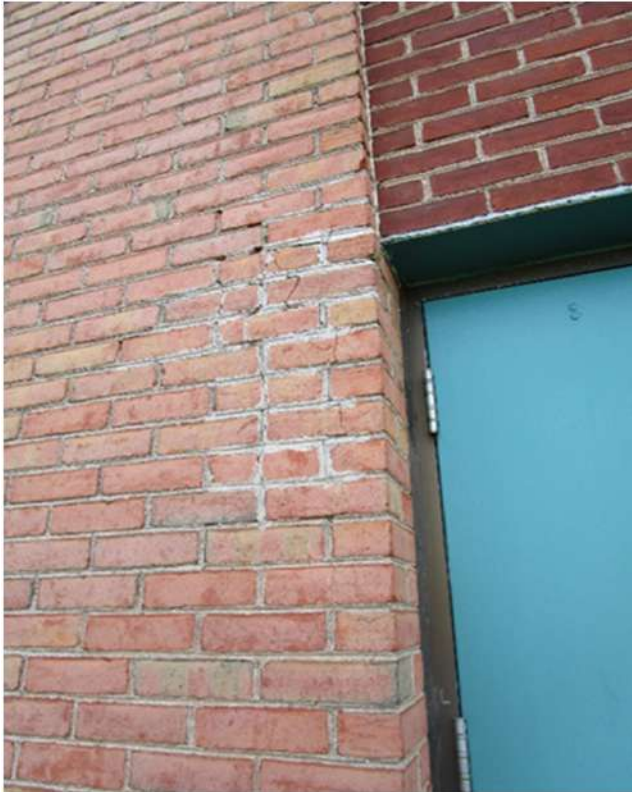
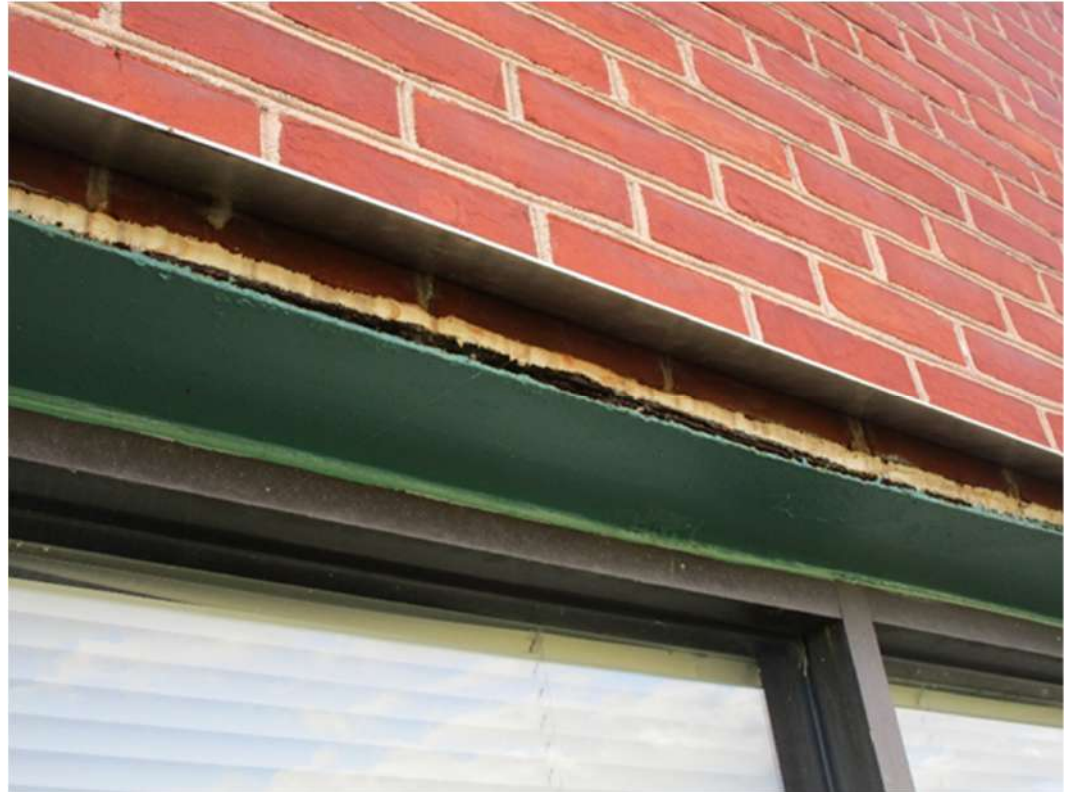
4. The exterior wall lintels at the East face of the second classroom wing are all (4) structurally damaged. [Photo 4A and 4B]
  - 4.1 Recommendation: Remove these W18 lintels and rebuilding a new CMU lintel over the windows at these four (4) locations.

Photos 4A and 4B: Second Classroom Wing East side lintels – replace lintel beam and masonry jambs

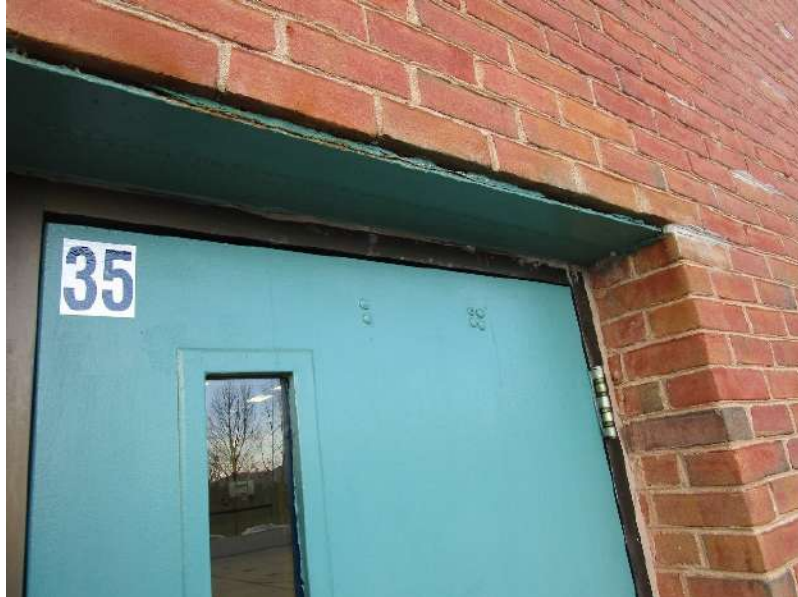
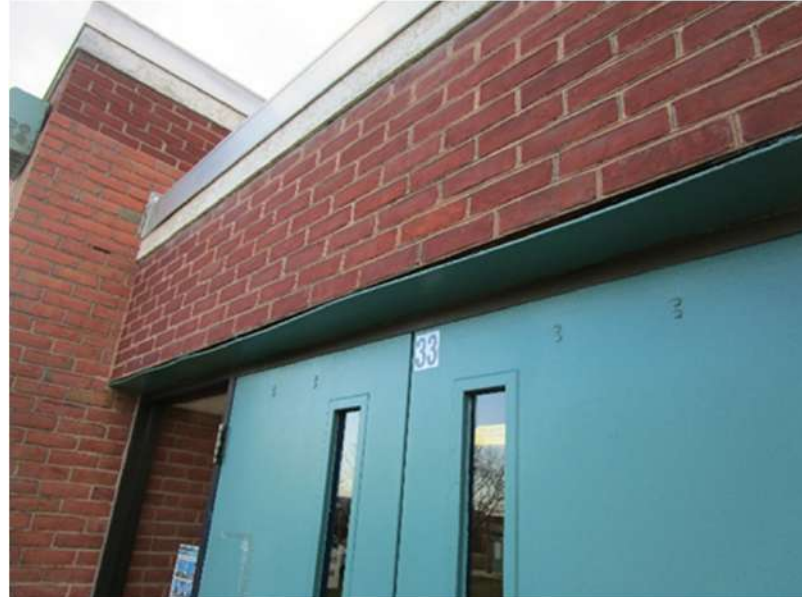
5. Lintels at exterior wall of gym and gym vestibule were extremely corroded.

Photos 5A and 5B: Gym and gym vestibule lintels – replace lintel beam and angles
