Springfield Prep Charter School

# Feasibility Study

2071 Roosevelt Ave, Springfield MA

# ***ACQUISITION PROPERTY CONDITION REPORT***

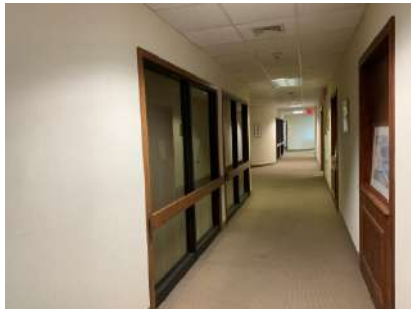
Typical interior construction.

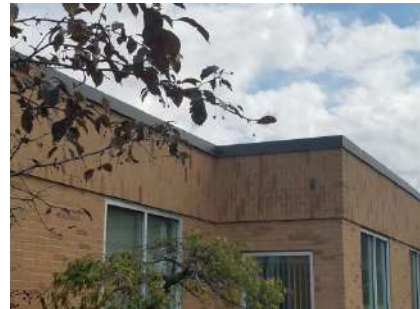
**Roof:** Single ply TPO membrane is in fair condition with evidence of ponding. Reported by owner to be 25 years old it is at the end of life expectancy.

Roof is low sloping with no parapet.

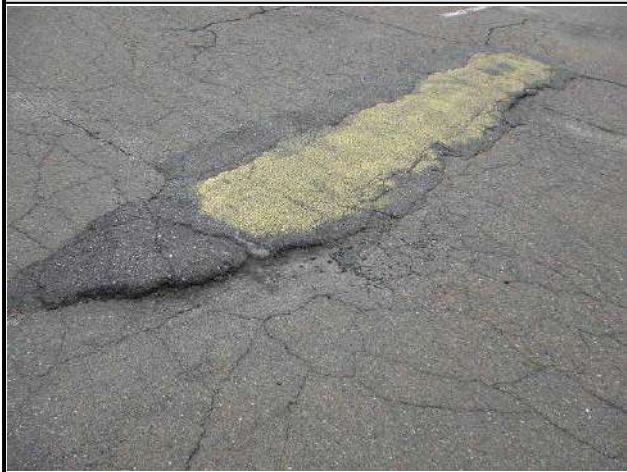
| <p>The asphalt speed bumps were severely worn with cracked and missing asphalt sections and faded paint.</p> | <p>All bollards provided throughout the parking lot areas and around the Subject building were found to have peeling paint and rusted sections.</p> |

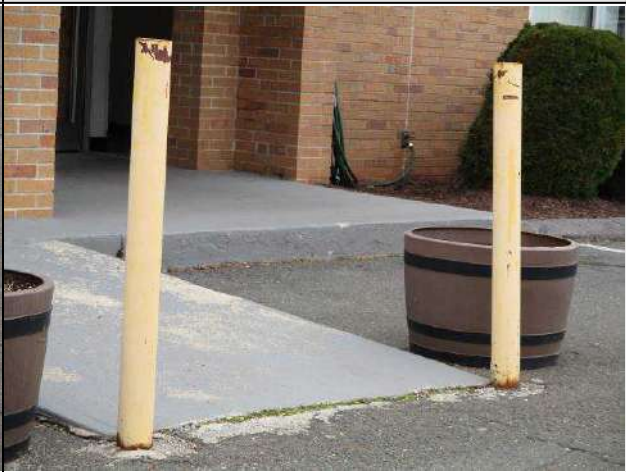
All bollards provided throughout the parking lot areas and around the Subject building were found to have peeling paint and rusted sections. Based on the observed conditions, Short Term Repairs are recommended for preparing, priming, and painting of all bollards

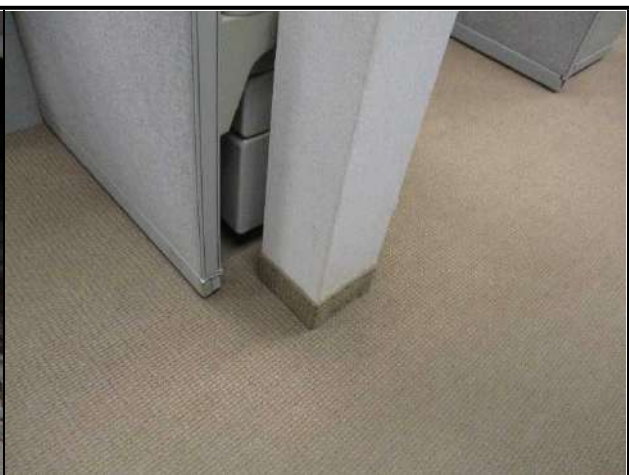
Interior column and slab obscured by carpet.

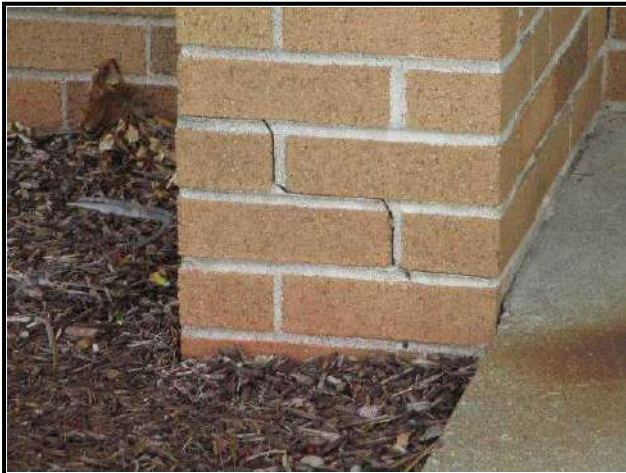
| Step crack in mortar at column labeled 2093. | The sealant between the building and the concrete step at the north-most rear door. |

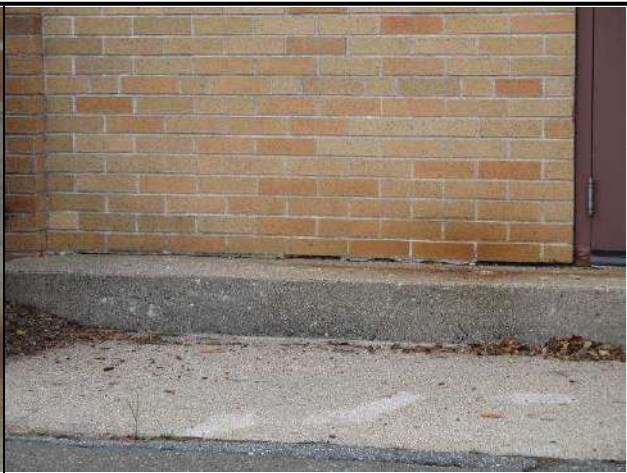
The observed sealants along the control joints appear to be in fair condition overall, with weathered and cracked sealant noted in several locations around the building. Based on the reported age, current condition, and expected useful life, Replacement Reserves are recommended for sealant and control joint renewal during the analysis term. Additionally, the sealant between the building and the concrete step at the north-most rear door appeared to be failing. Based on the observed conditions, Short Term Repairs are recommended to replace the sealant at this location.

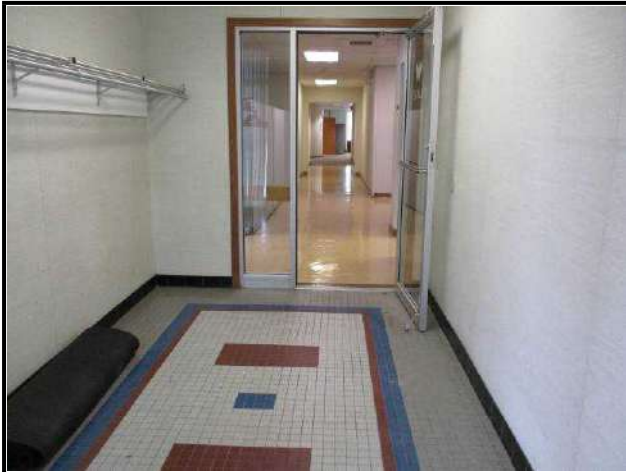
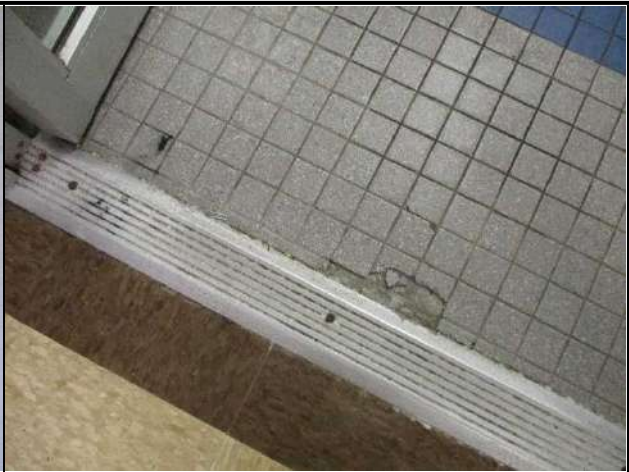
The entrance lobby and vestibule areas were found to be in generally good condition. However, cracked, damaged, and missing mosaic ceramic floor tiles were observed in several of the rear vestibules. Based on the observed conditions, Short Term Repairs are recommended to replace all cracked, damaged, or missing ceramic floor tiles.

| Cracked, damaged, and missing mosaic ceramic floor tiles in several of the rear vestibules. | Cracked, damaged, and missing mosaic ceramic floor tiles in several of the rear vestibules. |

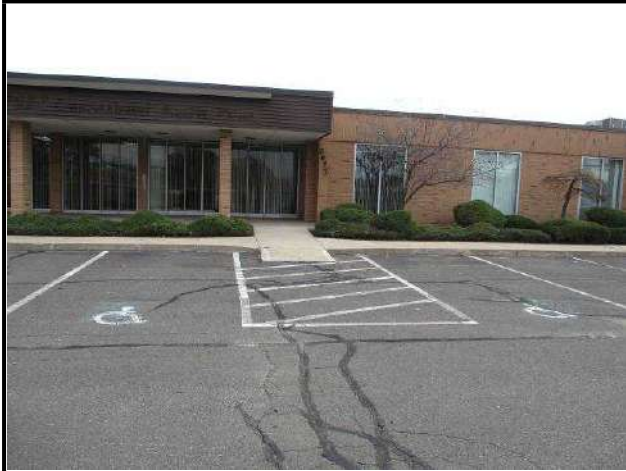
| Select accessible parking spaces do not have vertically-mounted signs | The total number of standard accessible spaces is not considered to be in compliance with ADA requirements. |

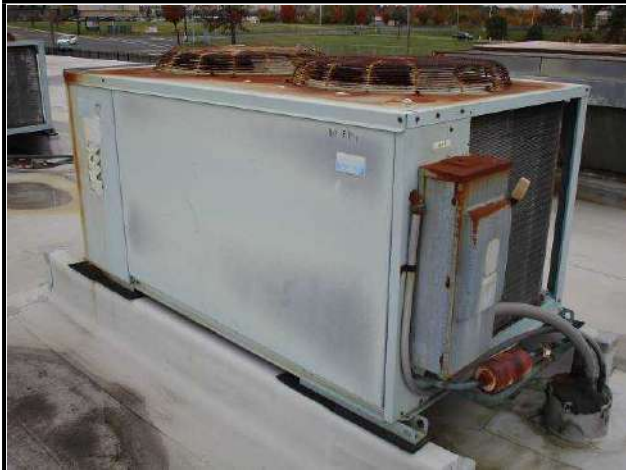
| Several RTUs appeared to be no longer in use. | All rooftop-mounted HVAC units were found to dispense condensate directly onto the roof membrane. |

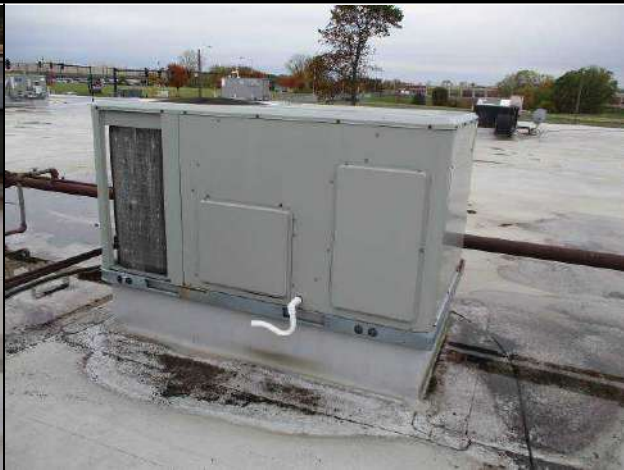
All rooftop-mounted HVAC units were found to dispense condensate directly onto the roof membrane. This can lead to advance degradation of the roof surface at these locations. Based on the observed conditions, Immediate Repairs we recommend all condensate be piped to roof drains.
