# VALLEY ELEMENTARY SCHOOL FEASIBILITY STUDY

Prepared for Frederick County Public Schools

By: Proffitt & Associates Architects

March 24, 2021

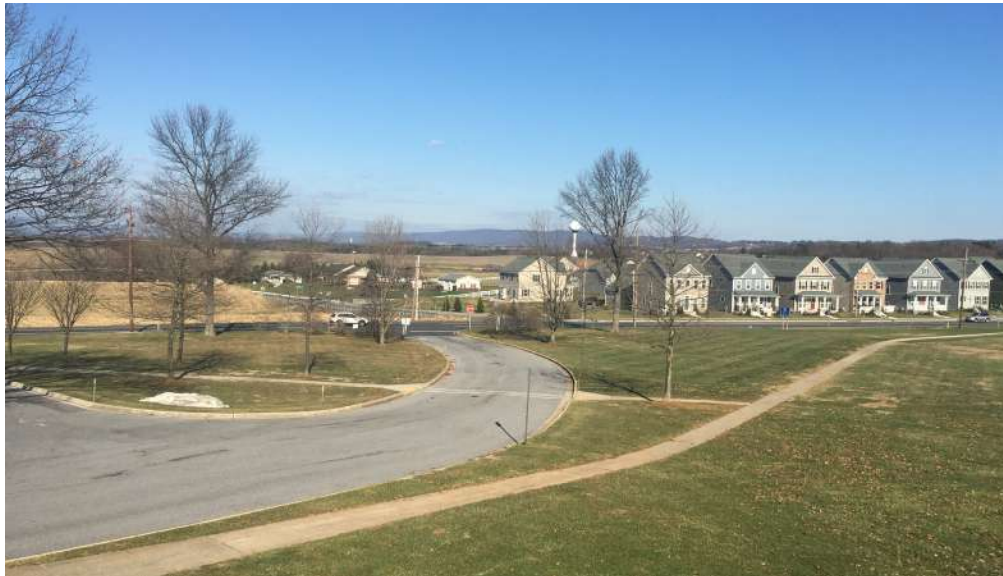
Vehicles access the site from a driveway from Horine Road, or a driveway from Jefferson Pike. Sight distance at Jefferson Pike appears adequate. However, sight distance for cars exiting during arrival/dismissal along Horine Road may be an issue. There is a sidewalk from Jefferson Pike that connects to the school. The sidewalk is compliant with ADA; however, there is a connection to a crosswalk at Puller Drive near the east end of the site that is not compliant. This newly constructed sidewalk is sloped at 6.7% and does not have handrails as required for slopes in excess of 5%.

View of bus loop entrance/exit to Jefferson Pike

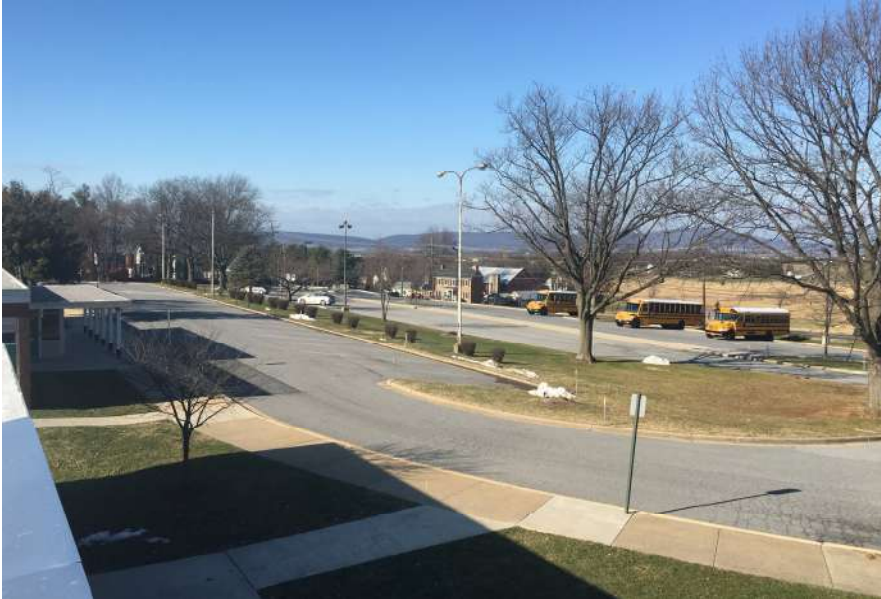
The current number of accessible spaces does not meet the minimum number per current ADA regulations; furthermore, current ADA requirements are based on each lot and not the site as a whole. Additionally, the signage and slope (in excess of 5%, maximum allowable is 2%) of these spaces do not meet current ADA regulations. During the design phase accessible spaces should be added to every parking area per ADA regulations. Overall, the drive aisles and parking areas appear to be in fair condition. Other paved areas of the site are utilized for parking, but these areas do not appear to be defined parking spaces.

North parking/bus loop

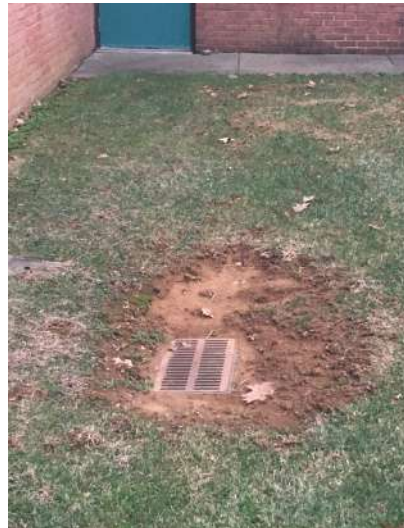
The areas around the building are relatively flat. It appears that attempts have been made over the years to correct the ponding water around the building, but they don't seem to have been effective. In particular there are many small yard drains that are set higher than the grade around them. Similarly, there is a downspout emptying into an area adjacent to the loading dock that does not seem to drain. Adjacent to a classroom the grade is almost level with the louver and may be allowing water into the building through this route.

Yard inlet drainage issues

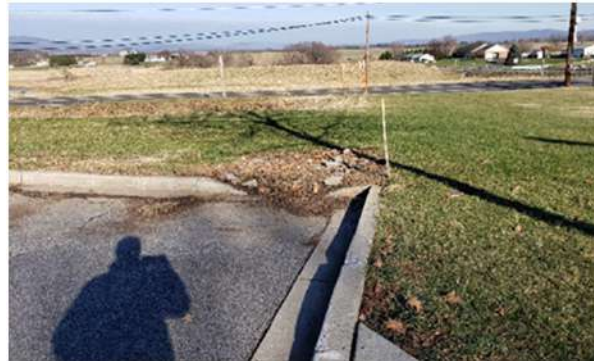
In addition, there is an existing surface stormwater management facility in the northwest corner of the property. This facility seems to have been designed to take drainage from the northern parking lot. However, the inflow to the facility seems to have been breeched and water is bypassing the stormwater facility and flowing out into Jefferson Pike. The inflow to this facility on the east side is full of sediment and has deteriorated the pavement and needs to be maintained before additional failures are seen.

Blocked SWM inflow at north parking area

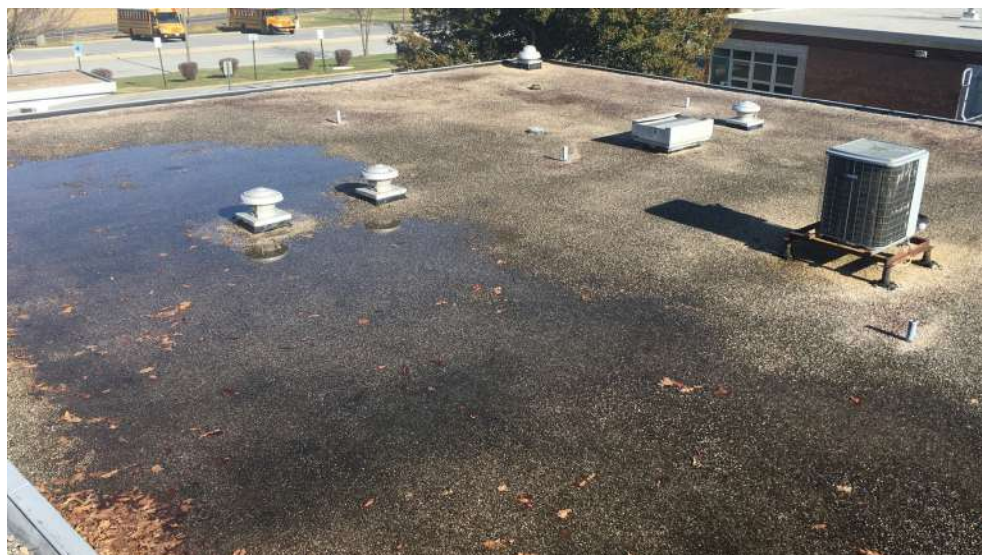
Standing water at roof area above main entry and administrative area

With the exception of a few small door overhangs, the roof is an existing built-up asphalt roofing system with gravel surfacing. Two door overhangs at the south side of the building have sloped asphalt shingle roofs. The built-up roofing over the main entry level portion of the building has not been replaced since 1994. The built-up roofing over the two classroom wings was replaced in 2015. The original classroom wing steel structure appears to be installed flat, with no slope for roof drainage. When the roof was replaced in 2015 it appears that tapered insulation was used to achieve a 1/4" minimum slope to the internal drains. The classroom addition structural plans show the steel joists with a double sloped top for drainage from a central high point, however the slope is listed as only 1/8" per foot. When the addition wing was re-roofed, an additional 1/8" of an inch per foot slope appears to have been provided via tapered polyiso insulation in order to achieve a total slope of 1/4" per foot. Insulation values for the roofing system appear to average at least R-30, which is the energy code prescriptive minimum for this type of application. The new roof drains do not appear to have a gravel stop per the details and gravel extends right up to the drain. In general, roof areas dating back to 1994 are in poor condition. There are a number of significant areas of standing water and there is moss growth on the lower kitchen/mechanical roof area to the west side of the cafetorium. The recently replaced roofs are in good condition. None of the roofs appear to have secondary drainage systems. The vertical distance between the drain and the top of the gravel stop/coping would need to be measured and a calculation of the roof's structural capacity to withstand the resulting standing water run to determine whether this would meet current codes.

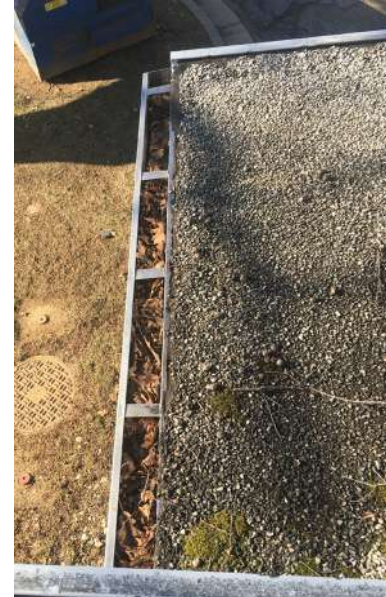
At all areas except the classroom addition, roof edges have prefinished aluminum gravel stops with fascia trim rather than parapets. The new classroom addition has a parapet with a prefinished aluminum coping cap. There is one area of the loading dock roof that has a metal gutter which is full of leaves. Some of the existing sealants are starting to show signs of age and may need to be replaced soon.

Loading Dock gutter

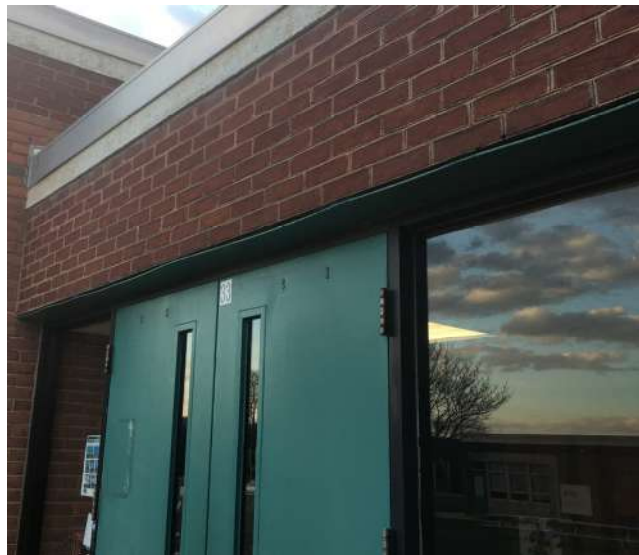
Gym addition exterior door lintel distortion

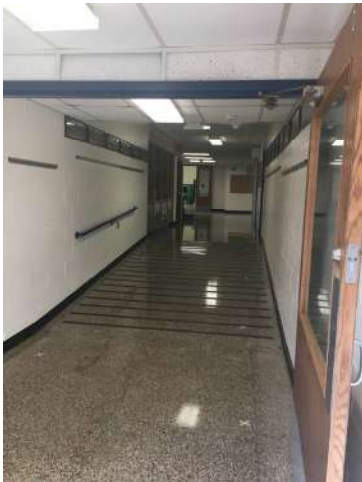
Corridor ramp is non-compliant due to slope and lack of railings

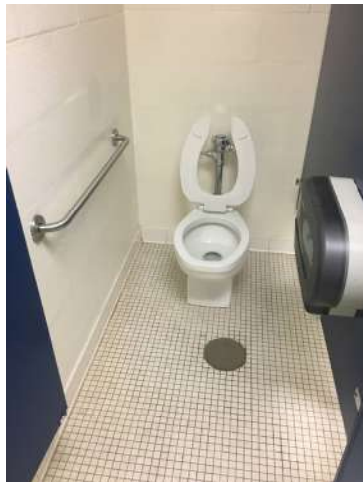
ADA stall dimensions are not met and required grab bars not provided

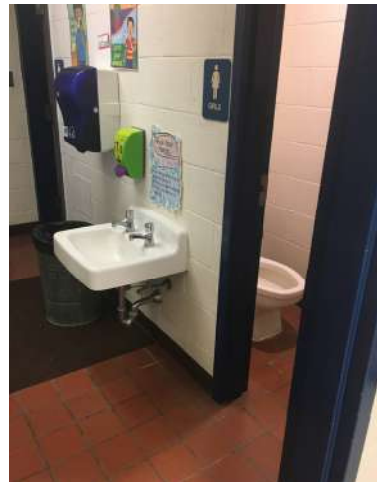
Single-user toilet rooms are not ADA compliant due to size and door width

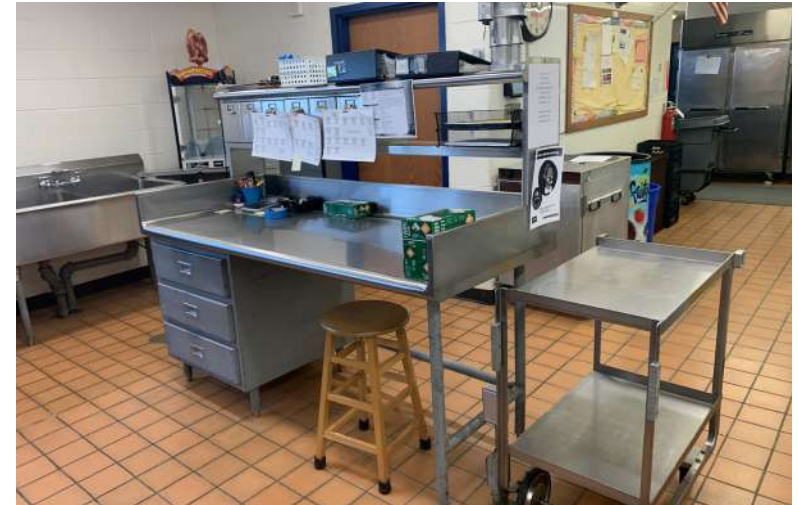
Kitchen work area with quarry tile flooring

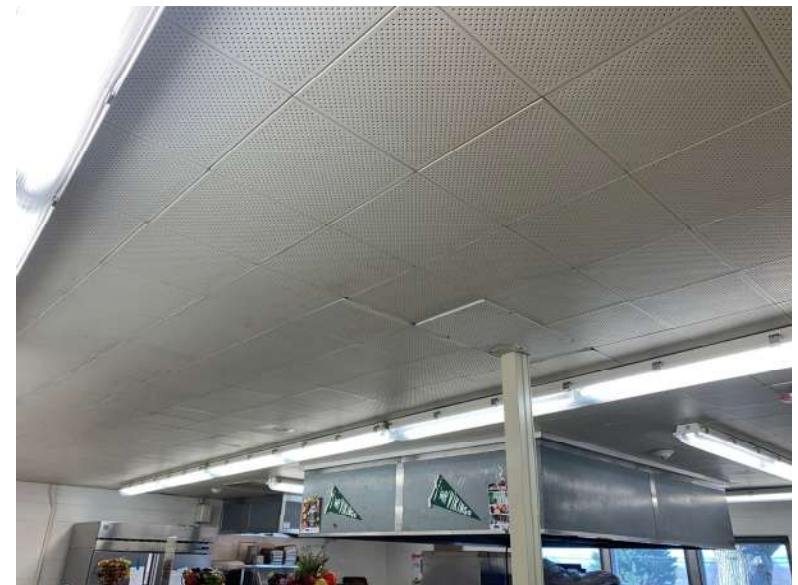
View of perforated ceiling tile

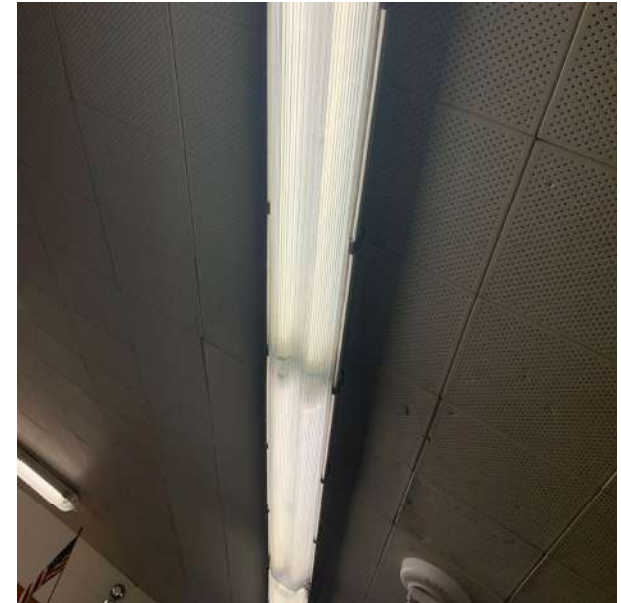
Twin bulb surface mounted light fixtures. Light level throughout space varies and is not adequate and some areas are not within current code standards.

View of surface mounted lighting

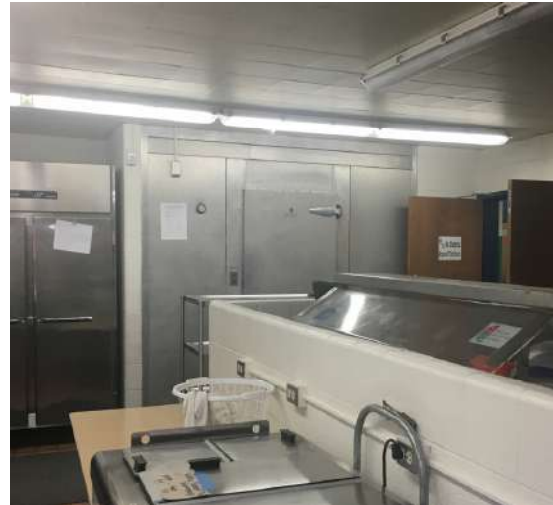
Unit is old and in fair/poor working condition and in constant need of repair. It is undersized for the number of students anticipated and is typically filled indicating the need for larger units. Flooring is galvanized steel and slippery when wet, adding to maintenance problems.

Walk-in Cooler

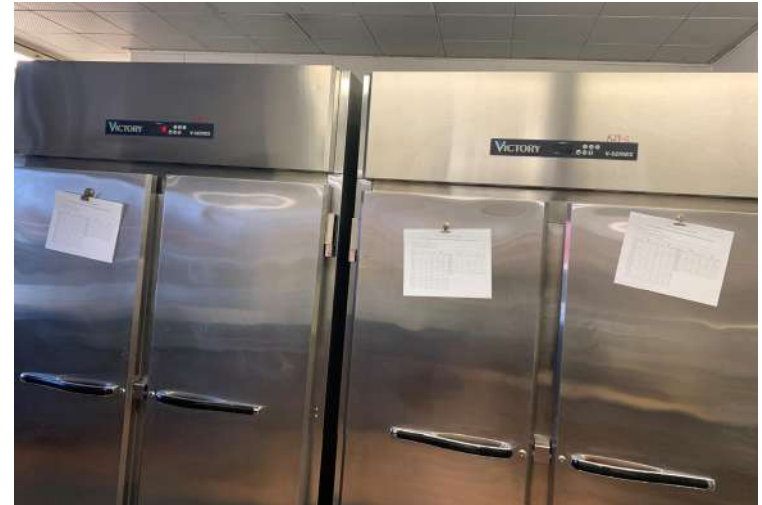
Reach-in Refrigerator and Freezer

There is one 2-section refrigerator and two 2-section freezer. Life cycle for this equipment is typically 10 years with normal wear and tear.

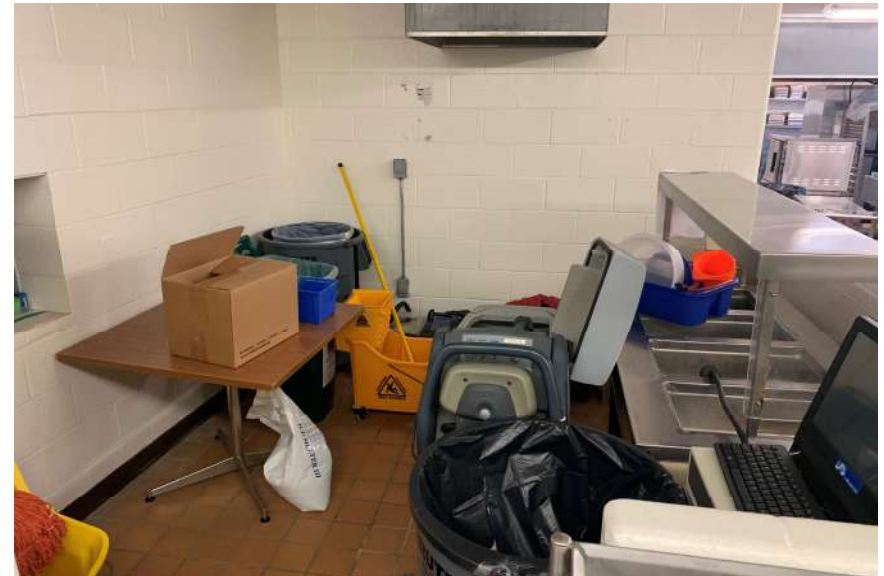
The Dish room equipment have been removed with the exception of the condensate hood still in place.

View of dishwashing area with equipment removed

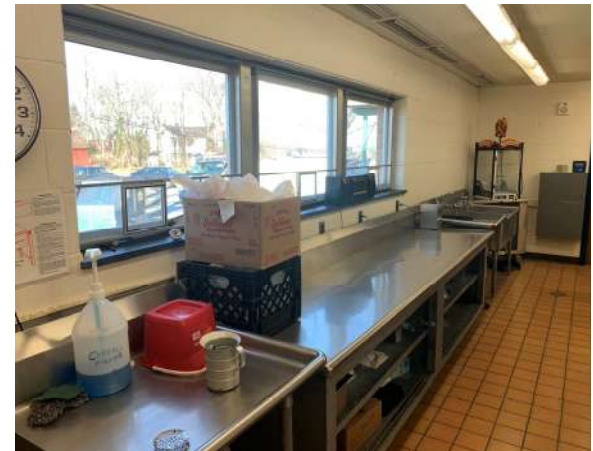
Worktables, Prep Sinks, Pot Sinks, and Hand Sinks - Original to building. Pot sink is in good/fair condition. Worktables are a repurposed baker's table and a table with a stainless-steel top and galvanized base which should be painted or replaced. The number of hand sinks is insufficient, not in compliance with current health code. Hand sinks are also made of porcelain.

Work counter area

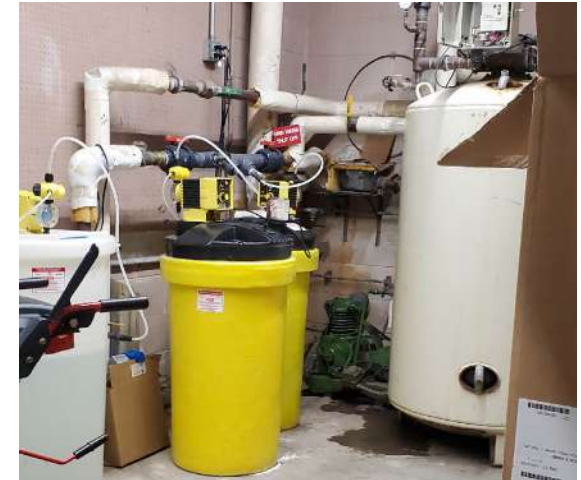
Water Treatment system

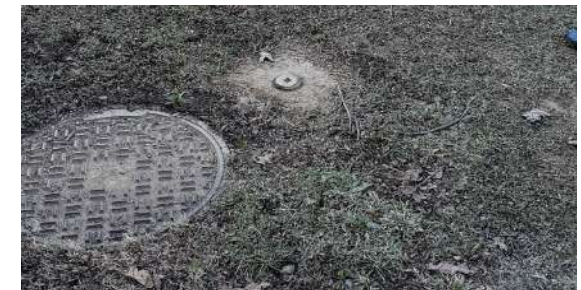
Grease Interceptor access

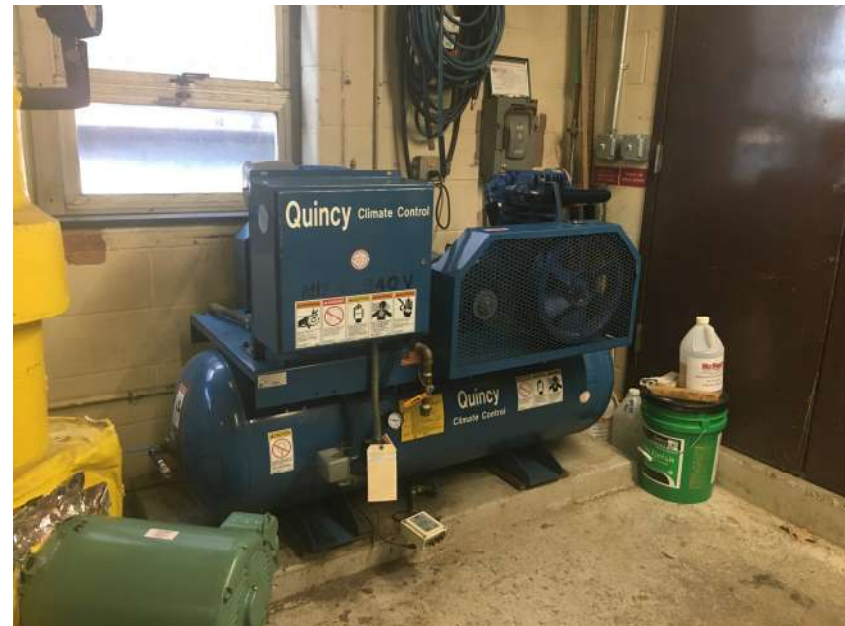
- g. Automatic Temperature Control ATC System: The system still utilizes pneumatic controls for actuation of dampers and valves. There is some Johnson Controls that serve the central heating and cooling plant and overlays the existing Barber Coleman Controls serving spaces. The Johnson Control system can monitor space temperatures and provide OCC-UNOCC Controls for scheduling.

Air compressor for pneumatic controls

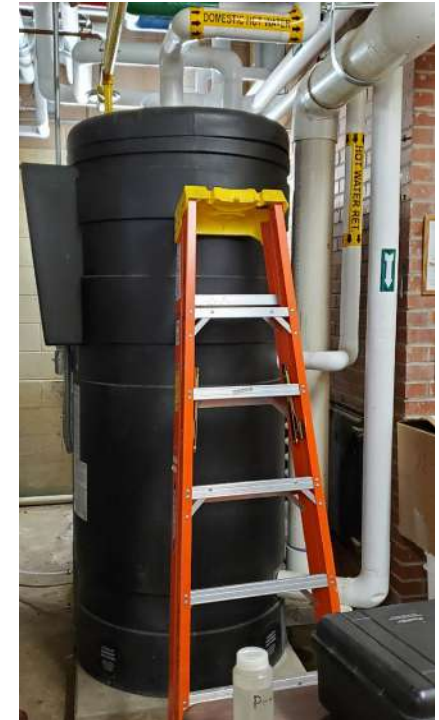
New hot water heater

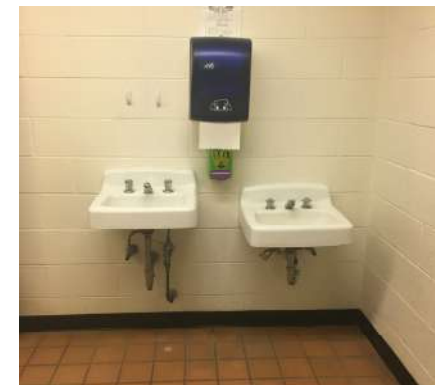
Typical wall hung lavatories

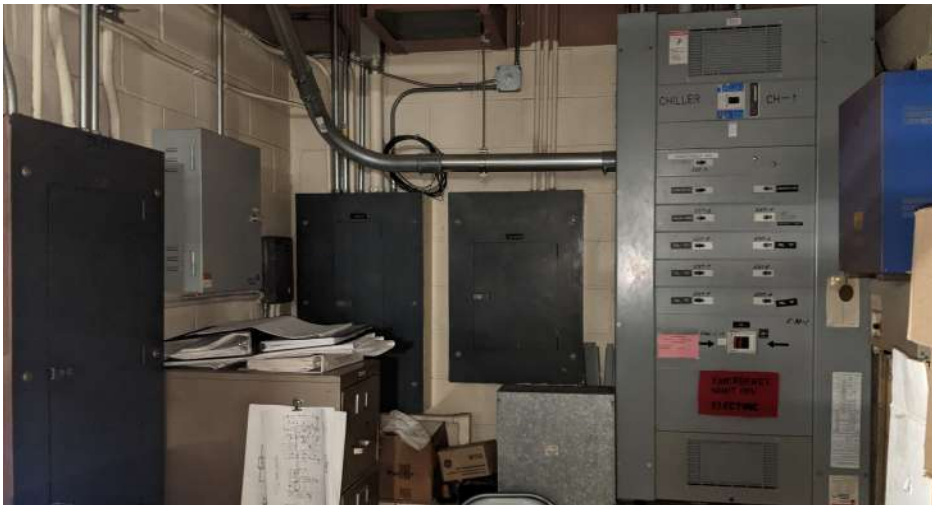
Electrical equipment and panels

1. Normal Power Distribution: It is recommended to increase the capacity and size of the incoming service to be a 2000A, 277/480 Volt, 3-Phase, 4-Wire Panelboard to accommodate any future additions or loads that may added. Branch panelboards should also be replaced since they are either at or approaching their recommended lifespans.

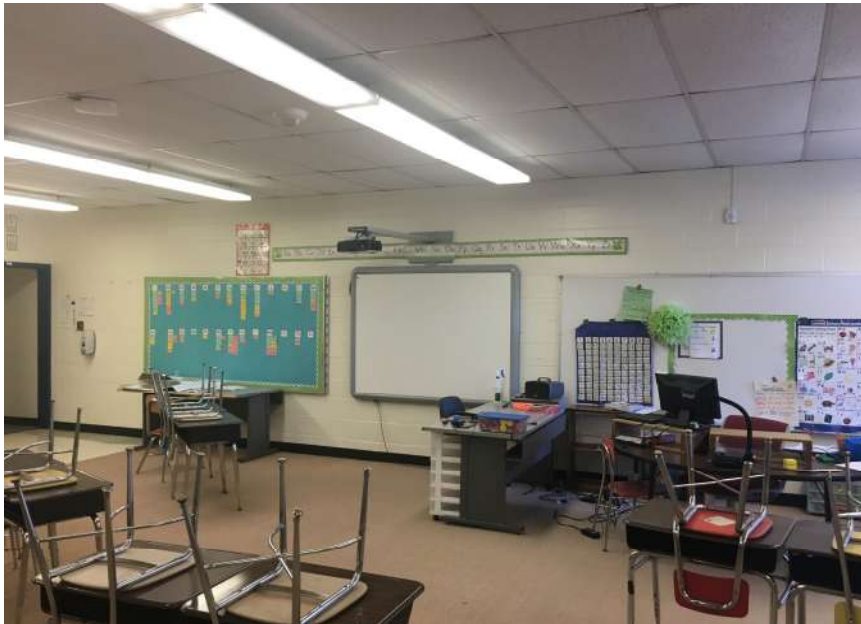
1. Lighting: There is a mixture of fluorescent 2' x 4' surface and recessed 4-lamp fixtures as well as 1' x 4' surface-mounted 2-lamp fixtures throughout the building. The existing gym and cafetorium use 2' x 4' industrial high bay fixtures. The site lighting is provided by Cobra head type light fixtures on steel poles as well as 1' x 1' square canopy surface mounted fixtures and wall packs around the perimeter of the building. There are currently no lighting controls to detect occupancy/vacancy. Toggle switches are used throughout the building.

Typical surface mounted lighting at original classroom wing

1. Lighting: It is recommended that all lighting fixtures be replaced with new LED-Type fixtures. Lighting controls should be added to allow customizable dimming and occupancy/vacancy sensing capabilities and to meet current energy codes. The overall efficiency of the building will increase with the change to LED fixtures.
