Springfield Prep Charter School

# Feasibility Study

2071 Roosevelt Ave, Springfield MA

# ***ACQUISITION PROPERTY CONDITION REPORT***

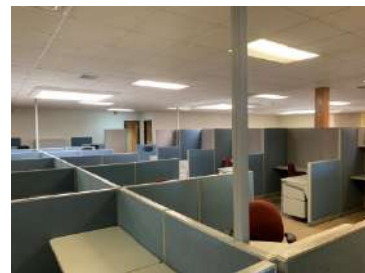
Typical interior cubicles within existing 24' column grid.

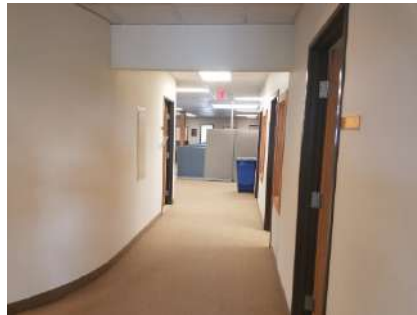
Typical carpet and hollow metal doorway

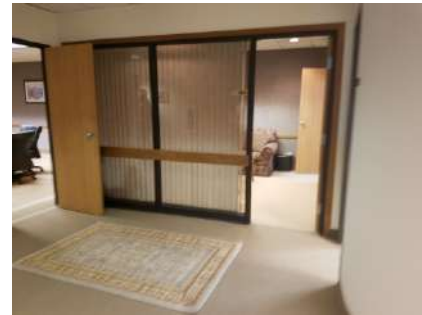
Typical interior glazed wall

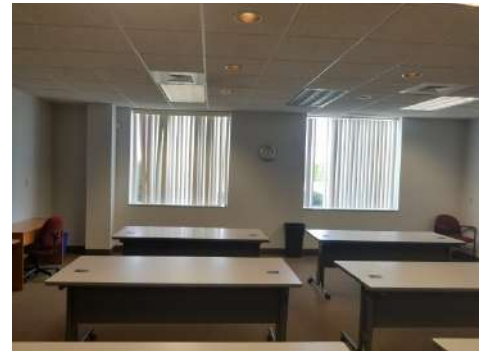
Acoustic tile ceiling and perimeter windows.

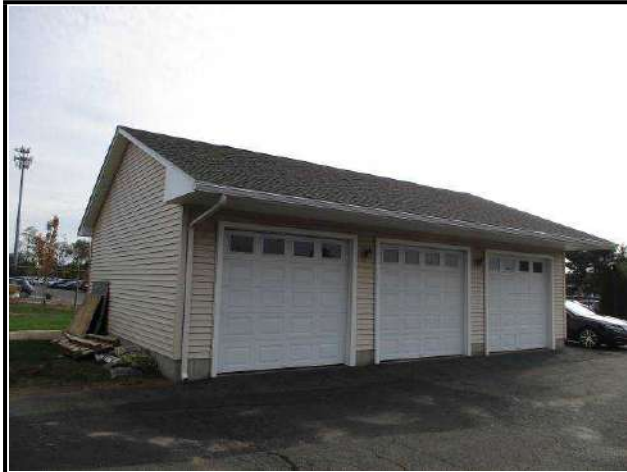
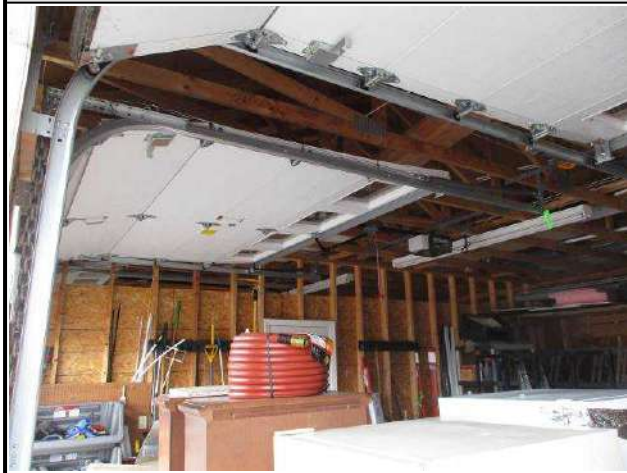
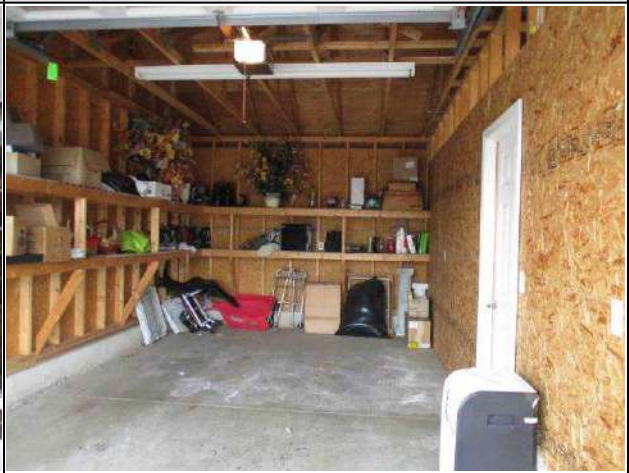
Maintenance garage building front and north side.

Maintenance garage building front and south side.

Maintenance garage building overhead doors.

Maintenance garage building interiors.

The Maintenance garage building located at the northeast corner of the Subject Property appears to be in good condition and will be maintained at the property as part of operational expenses during the analysis term.

Of note, stored materials were observed at the side of the garage building. Based on the observed conditions, Short Term Repairs are recommended to remove all stored materials.

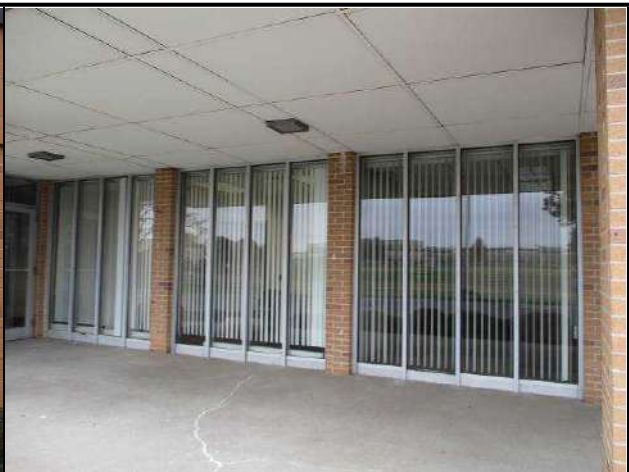
Typical storefront system at tenant entrances.

The observed storefront windows systems appeared to be weather tight and in good overall condition and will be maintained at the property as part of operational expenses during the analysis term.

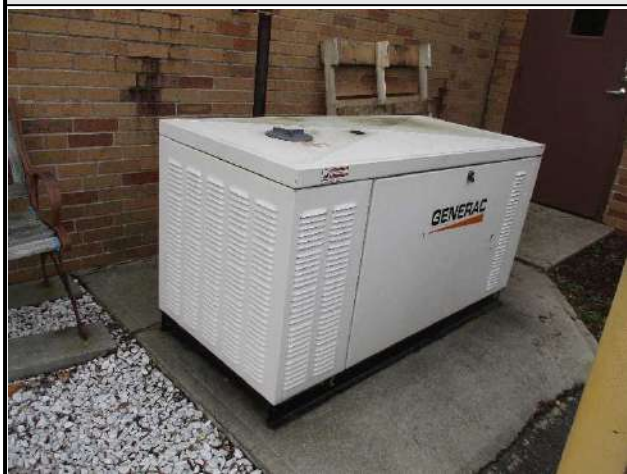
Emergency generator condition.
