Springfield Prep Charter School

# Feasibility Study

2071 Roosevelt Ave, Springfield MA

# ***ACQUISITION PROPERTY CONDITION REPORT***

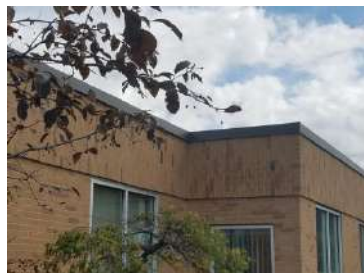
Brick veneer exterior with no parapet at roof.

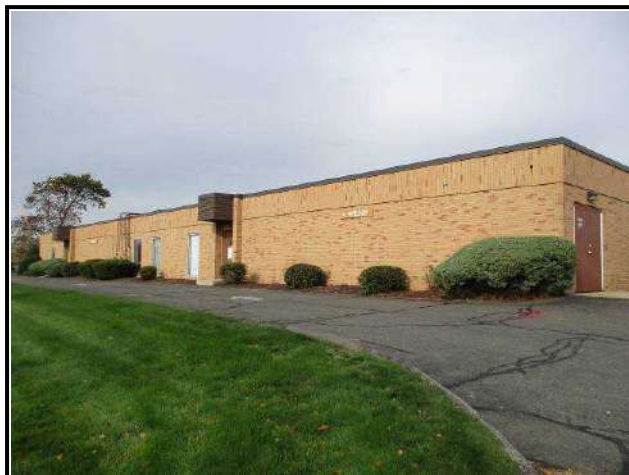
Mature landscaping provided at all sides of the building.

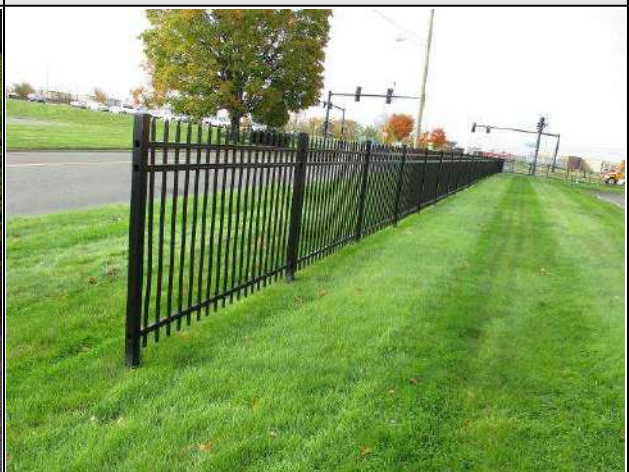
Painted metal fencing along the front and southeast property lines.

The fencing along the northwest and northeast property lines is in good condition and will be maintained at the property as part of operational expenses during the analysis term.

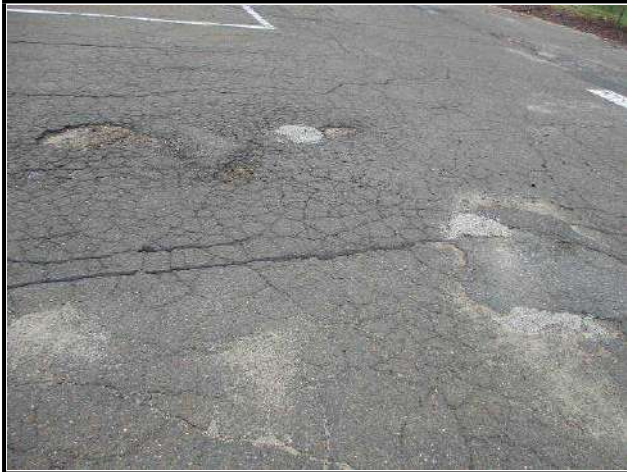
| <p>Typical asphalt pavement condition.</p> | <p>Typical extruded asphalt curb condition.</p> |

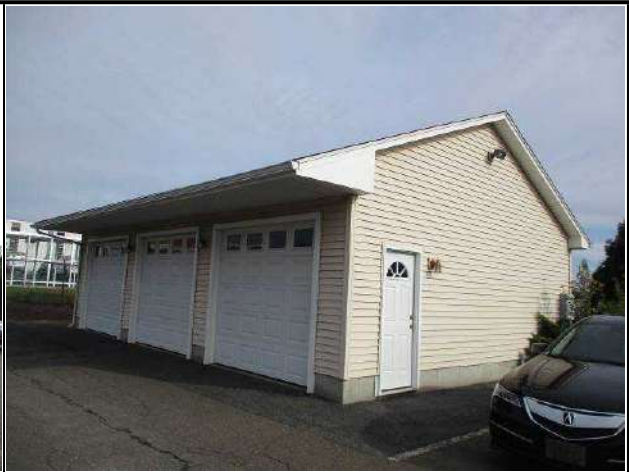
Maintenance garage building front and north side.

Maintenance garage building front and south side.

Maintenance garage building overhead doors.

Maintenance garage building interiors.

The Maintenance garage building located at the northeast corner of the Subject Property appears to be in good condition and will be maintained at the property as part of operational expenses during the analysis term.

Of note, stored materials were observed at the side of the garage building. Based on the observed conditions, Short Term Repairs are recommended to remove all stored materials.

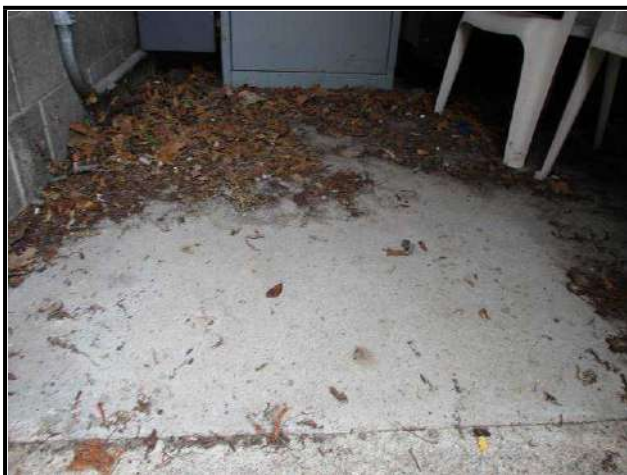
Typical slab section.

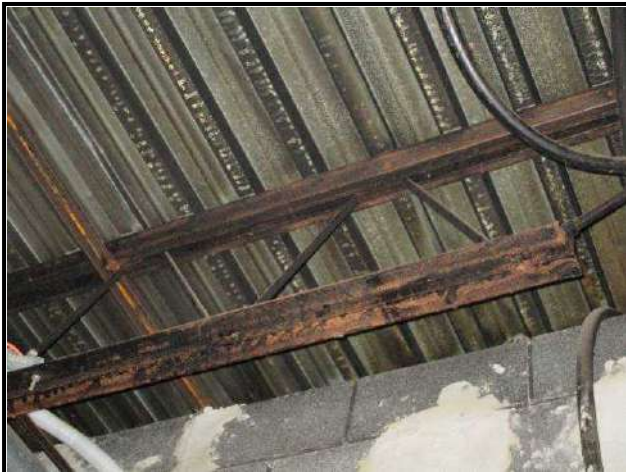
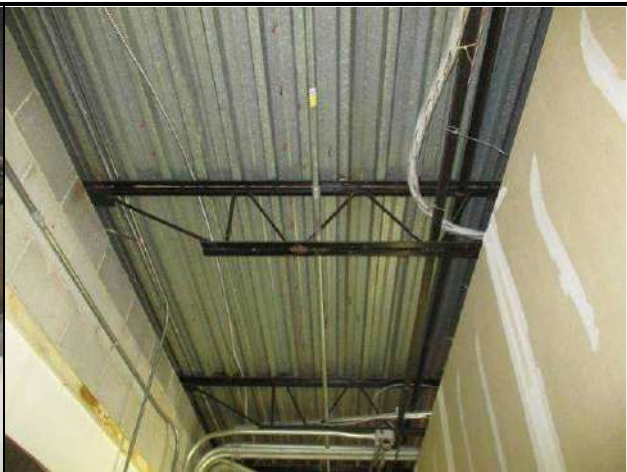
Based on limited observations, the superstructures appear to be in good to fair overall condition and appear to be performing as designed. No obvious indications of irregularities, including significant floor and/or roof deflections, significant cracks, noticeably out of plumb building elevations, or other perceived structural defects, were reported or observed. However, the open-web steel roof joists observed in the electrical rooms were found to have rusted sections. Based on the observed conditions, Immediate Repairs are recommended for an assessment of all open-web steel roof joists to determine if this condition is isolated to these areas, or if it is prevalent throughout the Subject Building. Additionally, Immediate Repairs are recommended for all affected joists to be prepped, primed, and painted.

- **Investigation and report by structural engineer**
- **Prepare, prime, and paint rusted open-web steel joists**

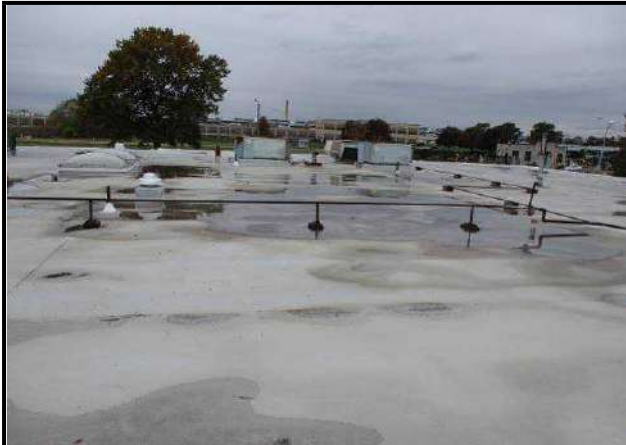
| TPO roof system. | Typical roof drain condition. |

The TPO roof appears to be in fair condition. The roof is a replacement and approximately 25 years old. Roofs of this type typically have an average effective useful life of approximately 15 to 20 years, depending on the property's location, material type and quality, quality of installation, roof maintenance and exposure, amount of roof traffic, and regional climatic conditions. Severe ponding was observed throughout the roof area. Based on the reported age, current condition, and expected useful life, Replacement Reserves are recommended for roof replacement during the analysis term.

The slope and drainage design of the building roof appeared to be generally inadequate with pervasive ponding noted at throughout the roof area. Based on observed conditions, we recommend that roof slopes are modified to provide positive drainage when the building roof is replaced.

- **TPO roof replacement**
- **Ongoing roof repairs & maintenance, after roof replacement**

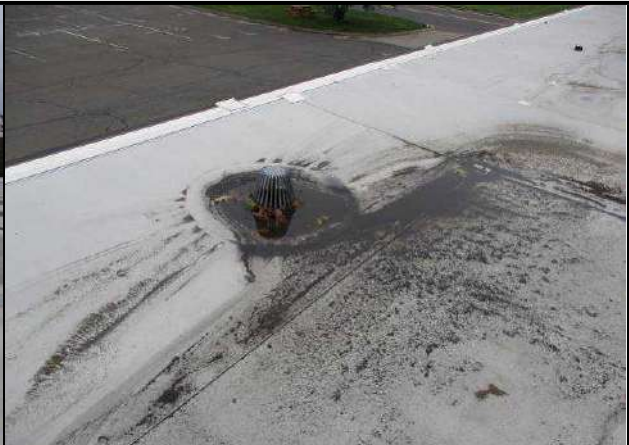
Additionally, several of the roof drains were found to be clogged with debris. This condition can lead to standing water on the roof membrane. Based on the observed conditions, Immediate Repairs are recommended to clean the roof drains of all debris.

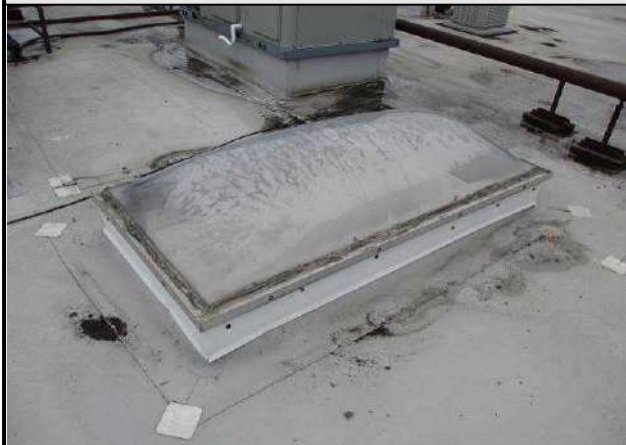
| Typical skylight condition. | Metal flashing around roof perimeter. |

The dome-type skylights were observed to be in good poor condition and will be maintained at the property as part of operational expenses during the analysis term.

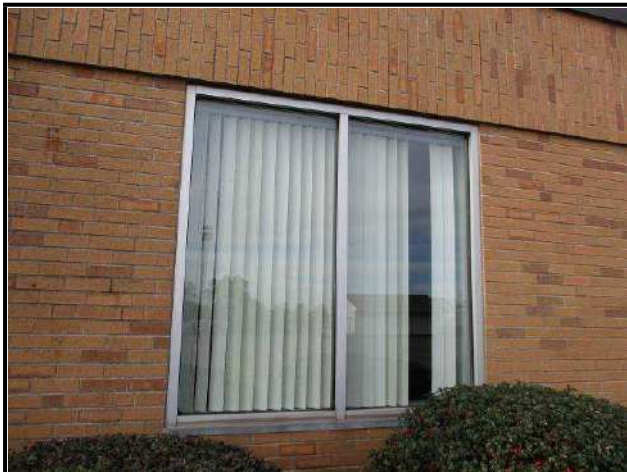
Typical fixed, punched, aluminum-framed window.

The observed windows appeared to be weather tight and in good overall condition. Based on the reported age, current condition, and expected useful life, Replacement Reserves are recommended for window replacement during the analysis term.

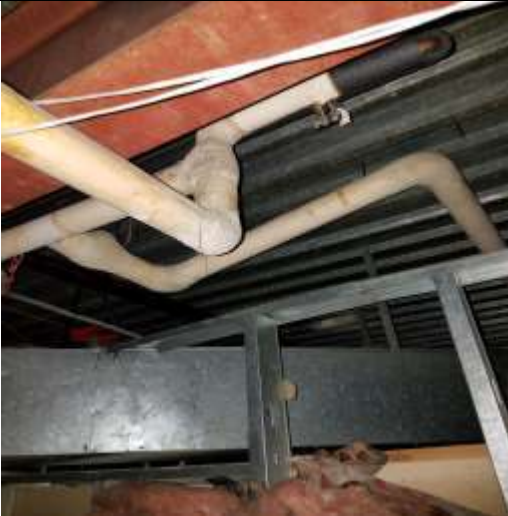
| Asbestos pipe fittings in cafeteria plenum | Janitor closet 2071, asbestos floor tile/mastic |

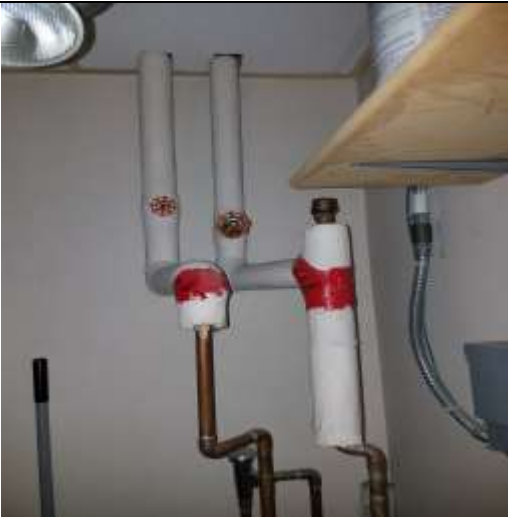
| Janitor closet 2071, asbestos pipe fittings | Asbestos ceiling panels at rear entrance |

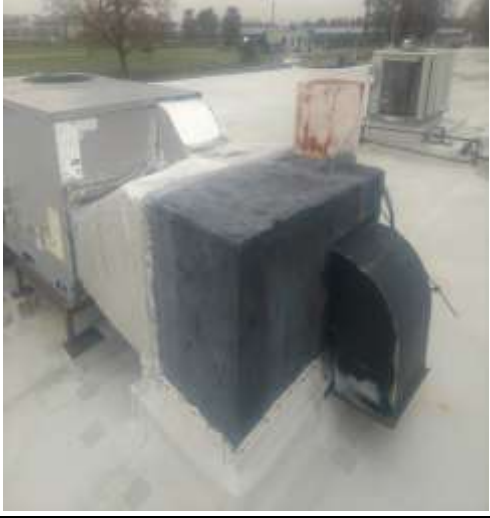
| Wall expansion, not asbestos | Tar mop on duct, asbestos |

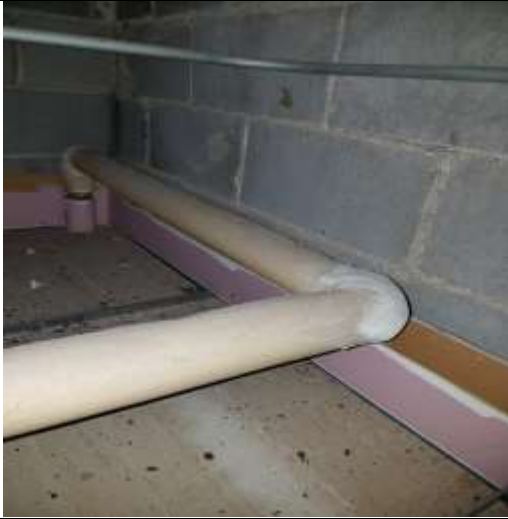
| Kindred space | Kindred plenum, fittings & JC, asbestos |

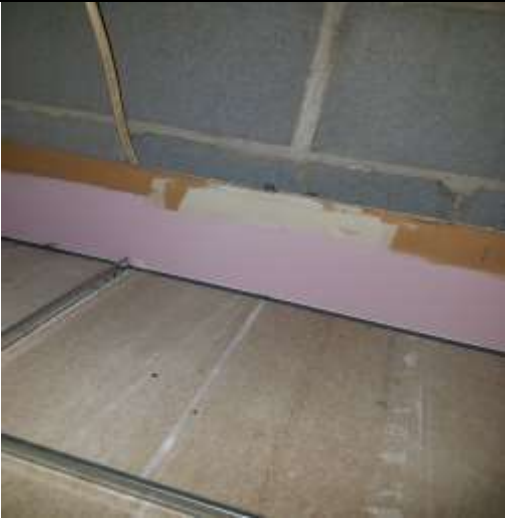
| Kindred plenum, tan JC, asbestos | Kindred cafeteria |

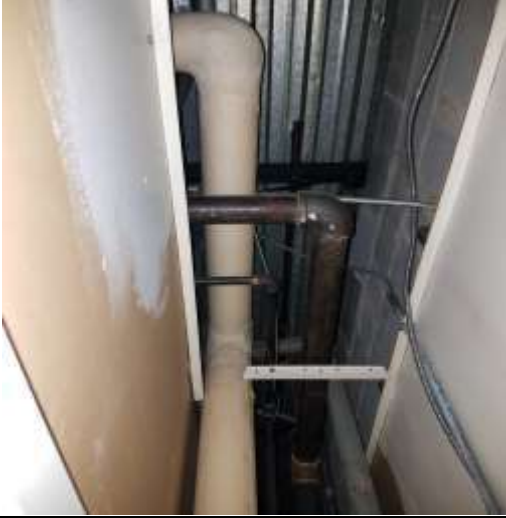
| Kindred space, asbestos fitting | Kindred floor tile/mastic under carpet, asbestos |

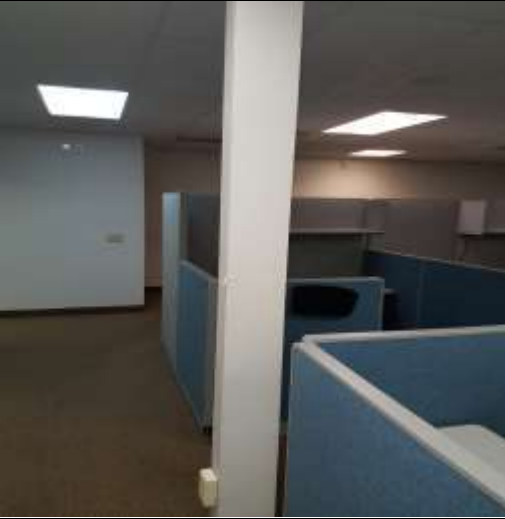
| S/E vacant space with asbestos JC | Lead paint glaze in bathroom ceramic wall |

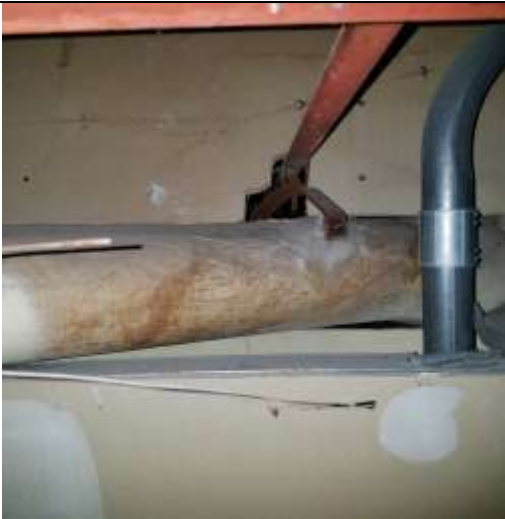
| Asbestos mud on drain hanger | Newer gypsum and JC in vacant section |

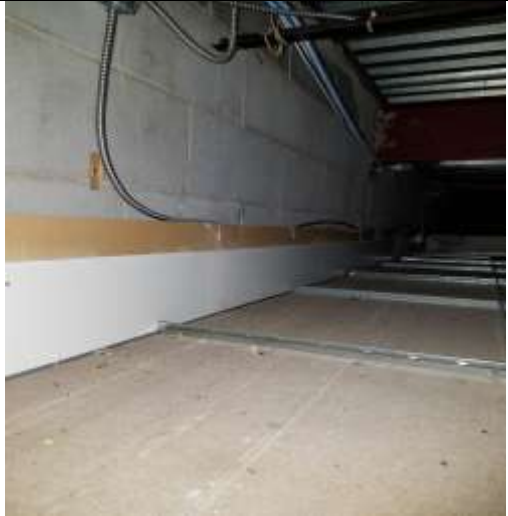
| S/E vacant section outer wall, asbestos JC | S/E vacant section new floor tile |

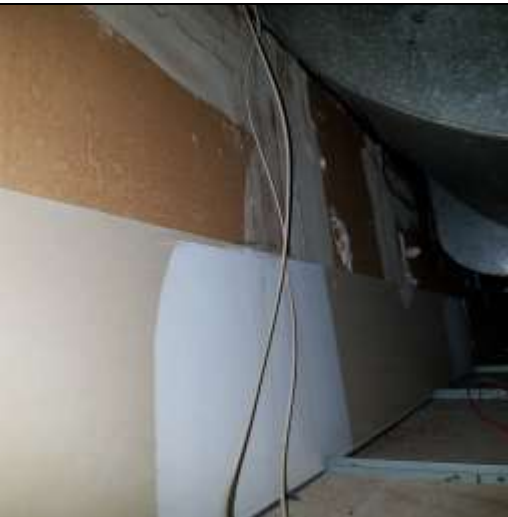
| Double layer gypsum/JC in S/E kick out hall | New gypsum double layer |

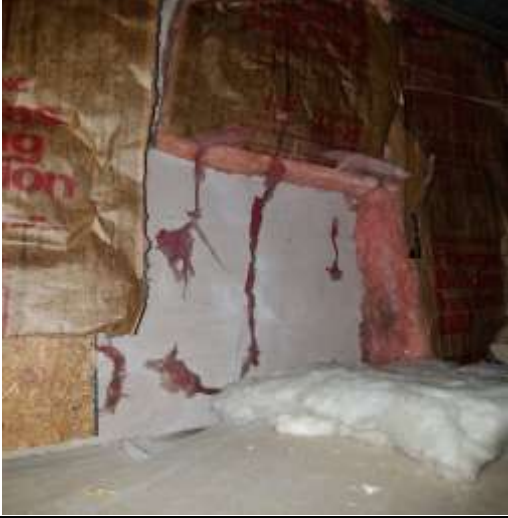
| Red insulation sealer glue, not asbestos | Vacant space cubical area |

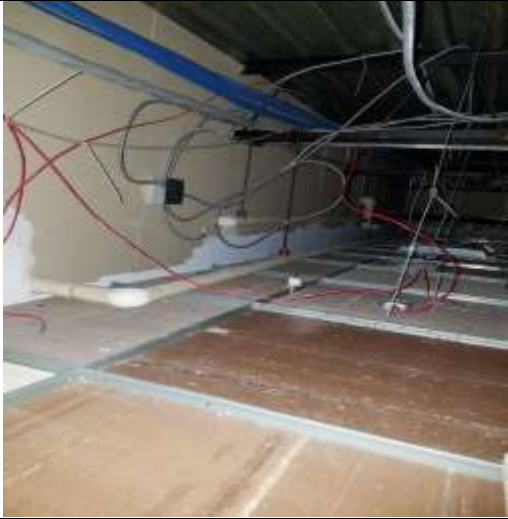
| New gypsum board in plenum | Old gypsum, tan JC and original wall stud |
